HOME REPORT

12 SHERMAN DRIVE
EAST KILBRIDE
GLASGOW
G74 5QH

Energy Performance Certificate (EPC)

Dwelling type: Semi-detached house
Date of assessment: 27 July 2023
Date of certificate: 31 July 2023
Total floor area: 82 m²
Primary Energy Indicator: 100 kWh/m²/year

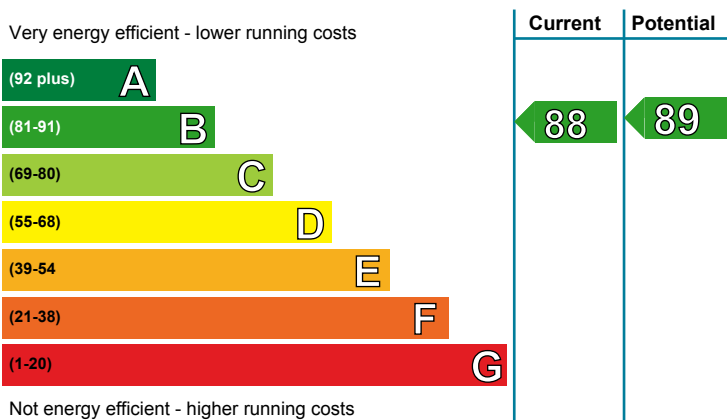
Energy Efficiency Rating

This graph shows the current efficiency of your home, taking into account both energy efficiency and fuel costs. The higher this rating, the lower your fuel bills are likely to be.

Your current rating is **band B (88)**. The average rating for EPCs in Scotland is **band D (61)**.

The potential rating shows the effect of undertaking all of the improvement measures listed within your recommendations report.

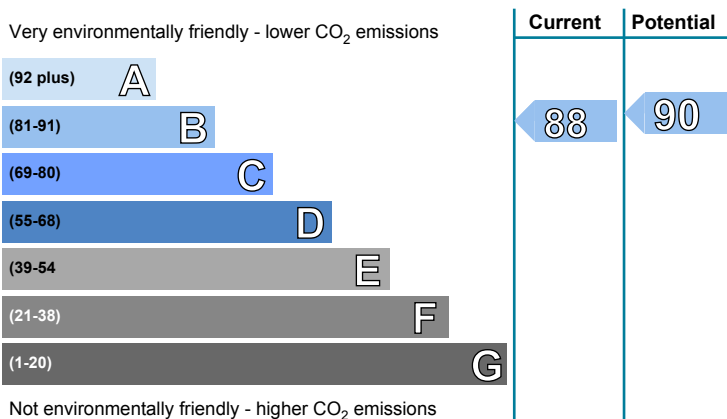
Environmental Impact (CO₂) Rating

This graph shows the effect of your home on the environment in terms of carbon dioxide (CO₂) emissions. The higher the rating, the less impact it has on the environment.

Your current rating is **band B (88)**. The average rating for EPCs in Scotland is **band D (59)**.

The potential rating shows the effect of undertaking all of the improvement measures listed within your recommendations report.
