HOME REPORT

28 MAPLE TERRACE
EAST KILBRIDE
GLASGOW
G75 9EG

ENERGY REPORT

Energy Performance Certificate (EPC)

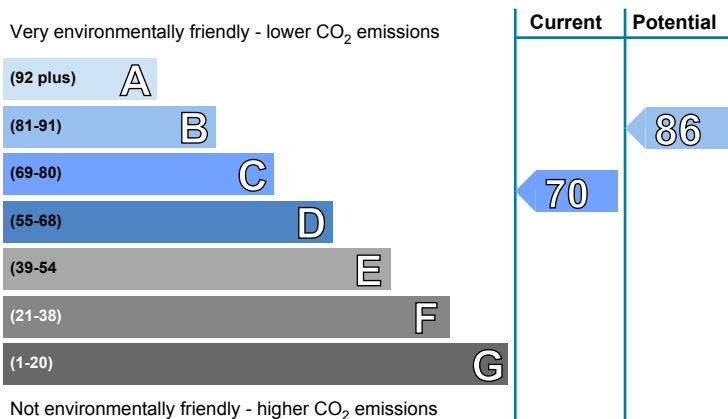
Environmental Impact (CO₂) Rating

This graph shows the effect of your home on the environment in terms of carbon dioxide (CO₂) emissions. The higher the rating, the less impact it has on the environment.

Your current rating is **band C (70)**. The average rating for EPCs in Scotland is **band D (59)**.

The potential rating shows the effect of undertaking all of the improvement measures listed within your recommendations report.
