# HOME REPORT

15 WESTBANK TERRACE  
RAVENSTRUTHER  
LANARK  
ML11 7SE

# Energy Performance Certificate (EPC)

15 WESTBANK TERRACE, RAVENSTRUTHER, LANARK, ML11 7SE

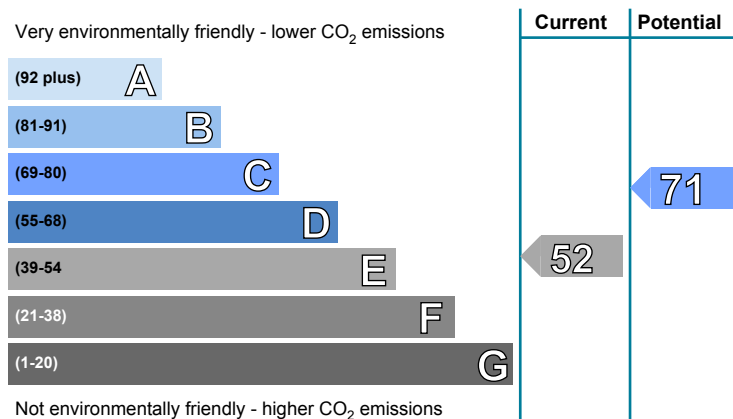
## Environmental Impact (CO<sub>2</sub>) Rating

This graph shows the effect of your home on the environment in terms of carbon dioxide (CO<sub>2</sub>) emissions. The higher the rating, the less impact it has on the environment.

Your current rating is **band E (52)**. The average rating for EPCs in Scotland is **band D (59)**.

The potential rating shows the effect of undertaking all of the improvement measures listed within your recommendations report.
