# HOME REPORT

# Energy Performance Certificate (EPC)

50 BELVEDERE AVENUE, EAST KILBRIDE, GLASGOW, G74 5DY

**Dwelling type:** End-terrace house  
**Date of assessment:** 25 February 2024  
**Date of certificate:** 29 February 2024  
**Total floor area:** 80 m<sup>2</sup>  
**Primary Energy Indicator:** 86 kWh/m<sup>2</sup>/year

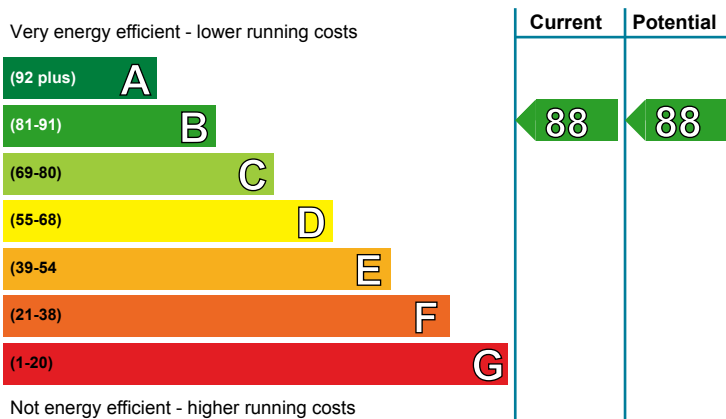
## Energy Efficiency Rating

This graph shows the current efficiency of your home, taking into account both energy efficiency and fuel costs. The higher this rating, the lower your fuel bills are likely to be.

Your current rating is **band B (88)**. The average rating for EPCs in Scotland is **band D (61)**.

The potential rating shows the effect of undertaking all of the improvement measures listed within your recommendations report.

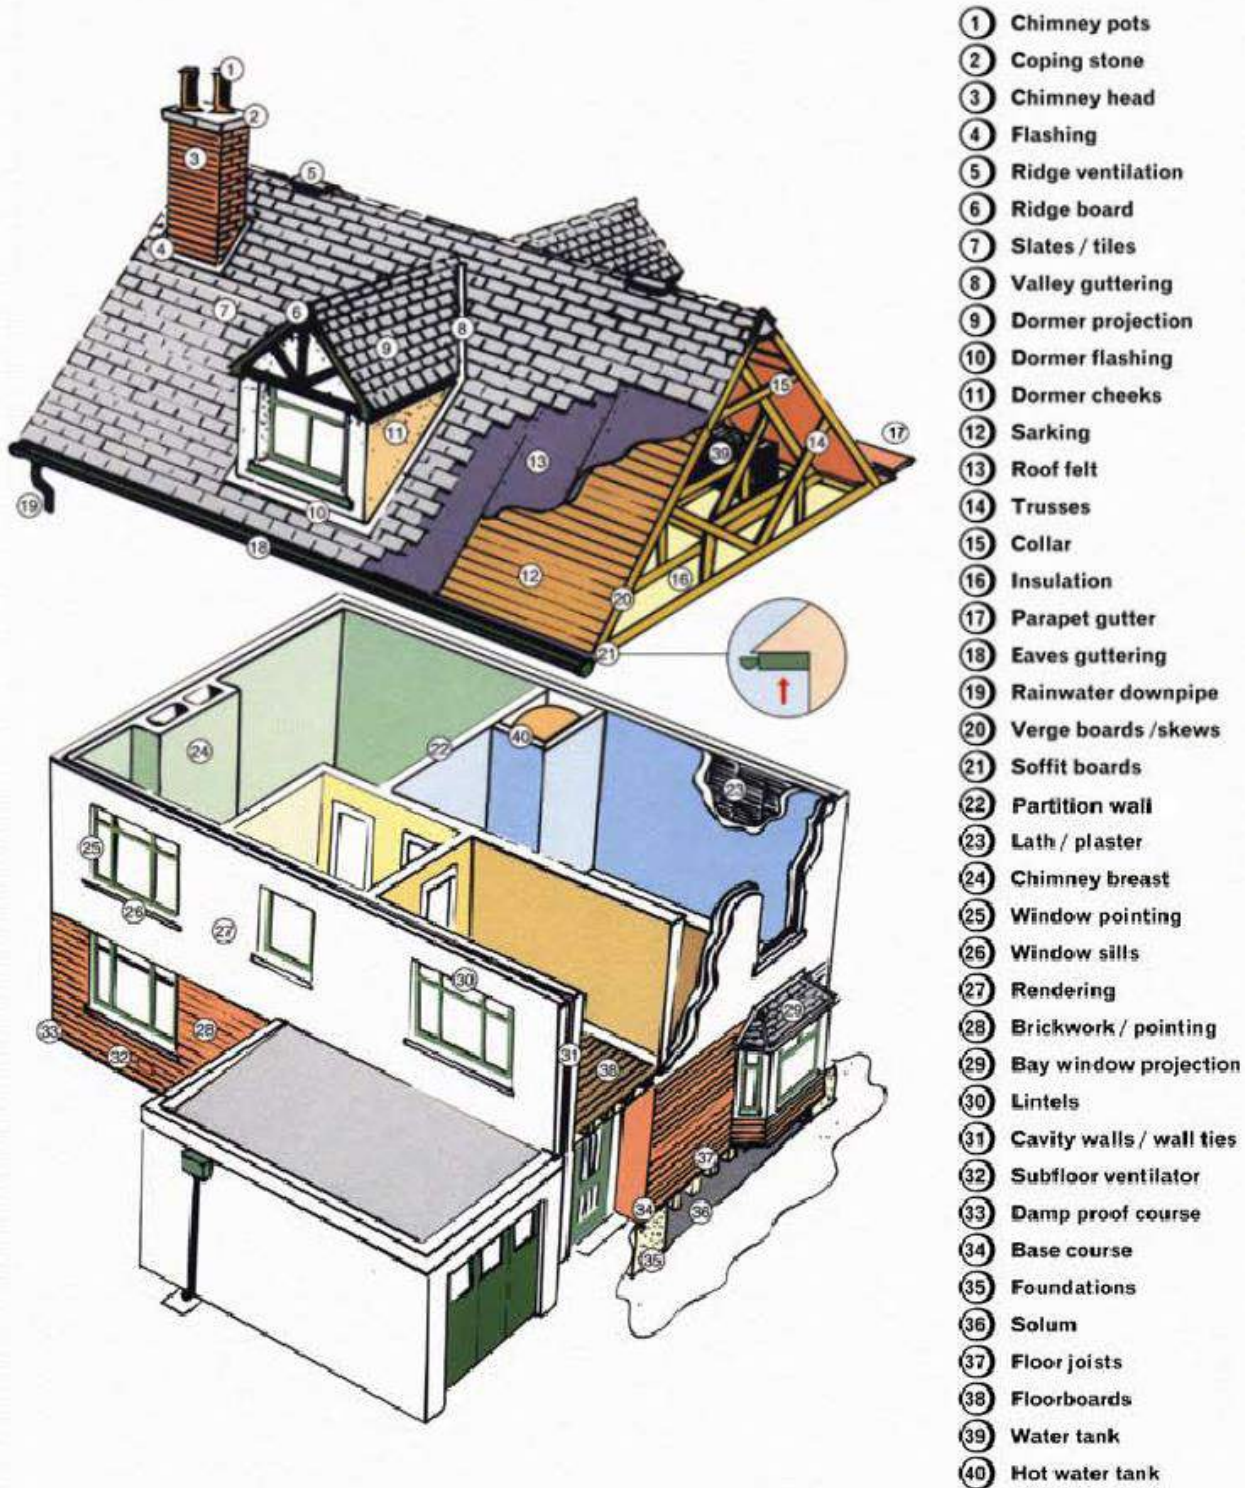
## Sectional Diagram showing elements of a typical house

Reference may be made in this report to some or all of the above component parts of the property. This diagram may assist you in locating and understanding these items.
