# Home Report

# Single Survey

<b>Property address</b>	9 Glen Gairn East Kilbride Glasgow G74 2JG
<b>Customer</b>	James Park
<b>Customer address</b>	9 Glen Gairn East Kilbride Glasgow G74 2JG
<b>Prepared by</b>	Shepherd Chartered Surveyors
<b>Date of inspection</b>	19/03/2024

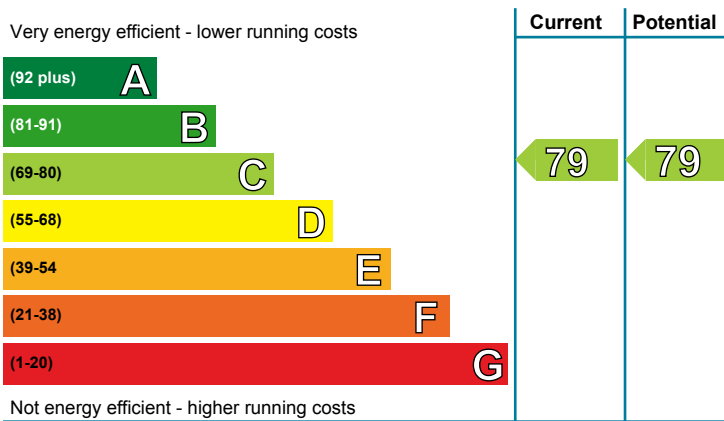
## Energy Efficiency Rating

This graph shows the current efficiency of your home, taking into account both energy efficiency and fuel costs. The higher this rating, the lower your fuel bills are likely to be.

Your current rating is **band C (79)**. The average rating for EPCs in Scotland is **band D (61)**.

The potential rating shows the effect of undertaking all of the improvement measures listed within your recommendations report.

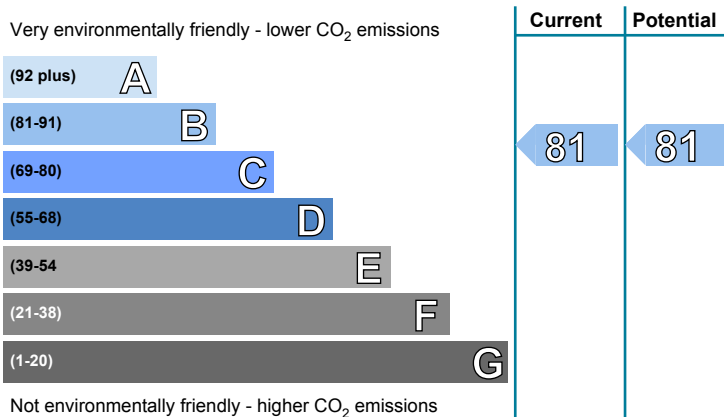
## Environmental Impact (CO<sub>2</sub>) Rating

This graph shows the effect of your home on the environment in terms of carbon dioxide (CO<sub>2</sub>) emissions. The higher the rating, the less impact it has on the environment.
