## HOME REPORT

46 TELFORD ROAD  
EAST KILBRIDE  
GLASGOW  
G75 0HW

# Energy Performance Certificate (EPC)

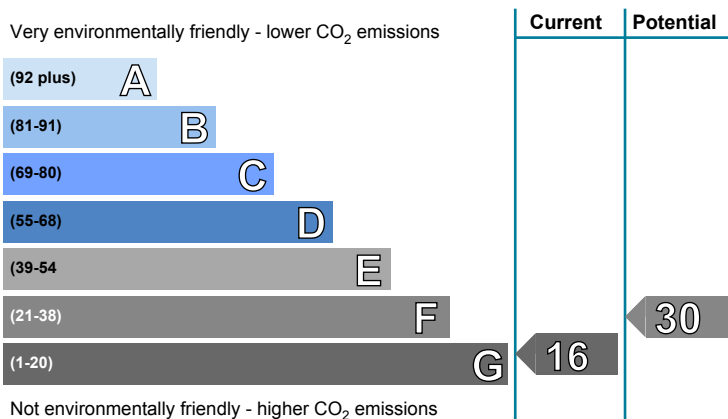
## Environmental Impact (CO<sub>2</sub>) Rating

This graph shows the effect of your home on the environment in terms of carbon dioxide (CO<sub>2</sub>) emissions. The higher the rating, the less impact it has on the environment.

Your current rating is **band G (16)**. The average rating for EPCs in Scotland is **band D (59)**.

The potential rating shows the effect of undertaking all of the improvement measures listed within your recommendations report.
