HOME REPORT

FLAT 3
218 EAGLESHAM ROAD
EAST KILBRIDE
GLASGOW
G75 8RH

Energy Performance Certificate (EPC)

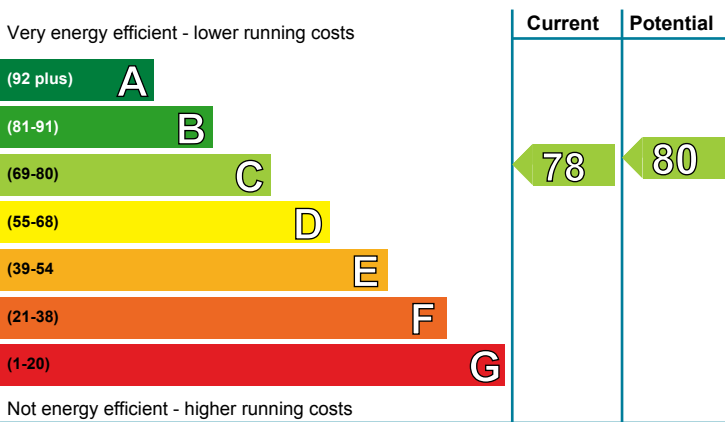
Energy Efficiency Rating

This graph shows the current efficiency of your home, taking into account both energy efficiency and fuel costs. The higher this rating, the lower your fuel bills are likely to be.

Your current rating is **band C (78)**. The average rating for EPCs in Scotland is **band D (61)**.

The potential rating shows the effect of undertaking all of the improvement measures listed within your recommendations report.

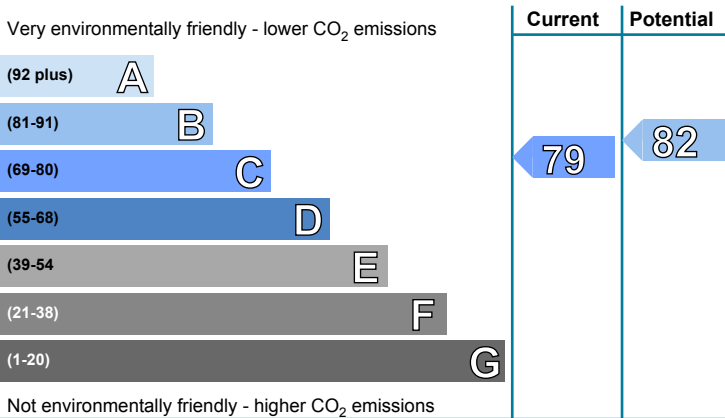
Environmental Impact (CO₂) Rating

This graph shows the effect of your home on the environment in terms of carbon dioxide (CO₂) emissions. The higher the rating, the less impact it has on the environment.

Your current rating is **band C (79)**. The average rating for EPCs in Scotland is **band D (59)**.

The potential rating shows the effect of undertaking all of the improvement measures listed within your recommendations report.
