## HOME REPORT

13 GLEN GROVE  
EAST KILBRIDE  
GLASGOW  
G75 0BG

# ENERGY REPORT

# Energy Performance Certificate (EPC)

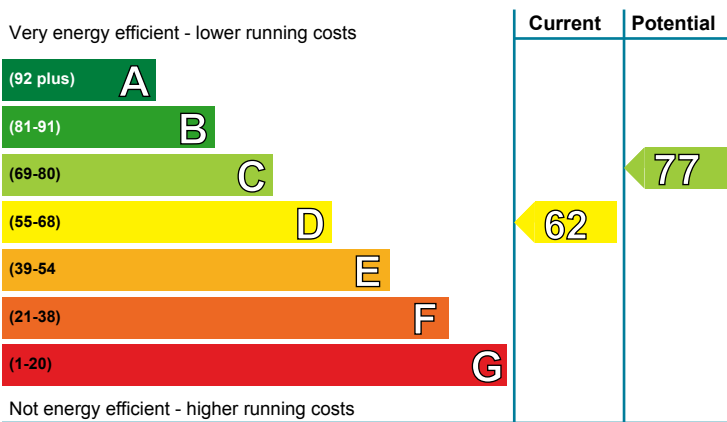
## Energy Efficiency Rating

This graph shows the current efficiency of your home, taking into account both energy efficiency and fuel costs. The higher this rating, the lower your fuel bills are likely to be.

Your current rating is **band D (62)**. The average rating for EPCs in Scotland is **band D (61)**.

The potential rating shows the effect of undertaking all of the improvement measures listed within your recommendations report.

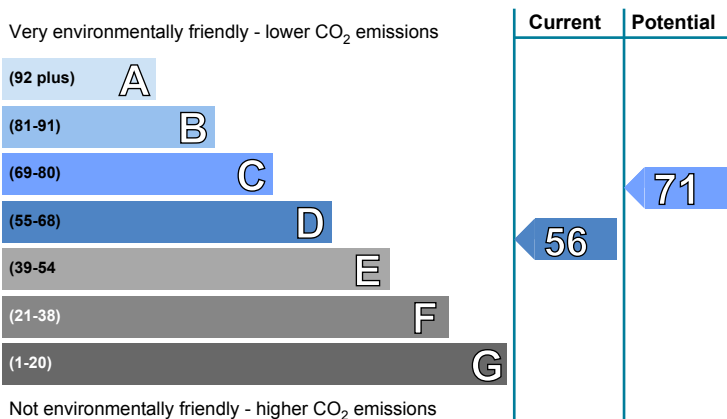
## Environmental Impact (CO<sub>2</sub>) Rating

This graph shows the effect of your home on the environment in terms of carbon dioxide (CO<sub>2</sub>) emissions. The higher the rating, the less impact it has on the environment.

Your current rating is **band D (56)**. The average rating for EPCs in Scotland is **band D (59)**.

The potential rating shows the effect of undertaking all of the improvement measures listed within your recommendations report.
