HOME REPORT

75 WESTWOOD HILL
EAST KILBRIDE
GLASGOW
G75 8DN

Energy Performance Certificate (EPC)

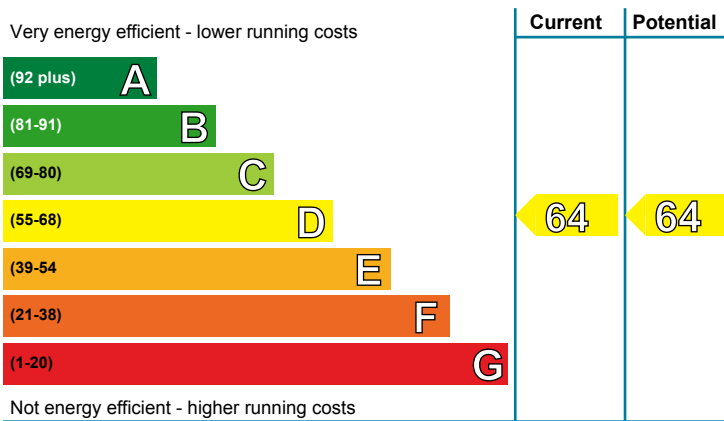
Energy Efficiency Rating

This graph shows the current efficiency of your home, taking into account both energy efficiency and fuel costs. The higher this rating, the lower your fuel bills are likely to be.

Your current rating is **band D (64)**. The average rating for EPCs in Scotland is **band D (61)**.

The potential rating shows the effect of undertaking all of the improvement measures listed within your recommendations report.

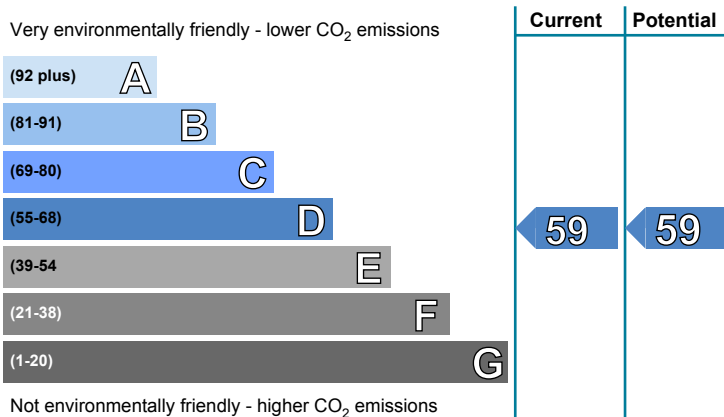
Environmental Impact (CO₂) Rating

This graph shows the effect of your home on the environment in terms of carbon dioxide (CO₂) emissions. The higher the rating, the less impact it has on the environment.

Your current rating is **band D (59)**. The average rating for EPCs in Scotland is **band D (59)**.

The potential rating shows the effect of undertaking all of the improvement measures listed within your recommendations report.
