## HOME REPORT

11 TASSIE PLACE  
EAST KILBRIDE  
GLASGOW  
G74 3EB

# Energy Performance Certificate (EPC)

11 TASSIE PLACE, EAST KILBRIDE, GLASGOW, G74 3EB

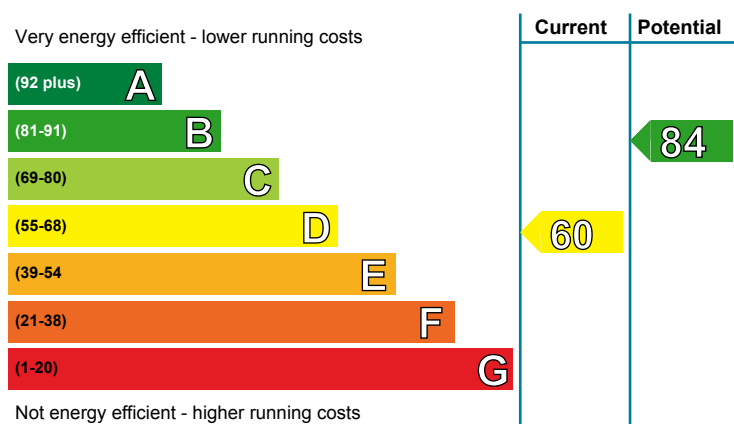
## Energy Efficiency Rating

This graph shows the current efficiency of your home, taking into account both energy efficiency and fuel costs. The higher this rating, the lower your fuel bills are likely to be.

Your current rating is **band D (60)**. The average rating for EPCs in Scotland is **band D (61)**.

The potential rating shows the effect of undertaking all of the improvement measures listed within your recommendations report.

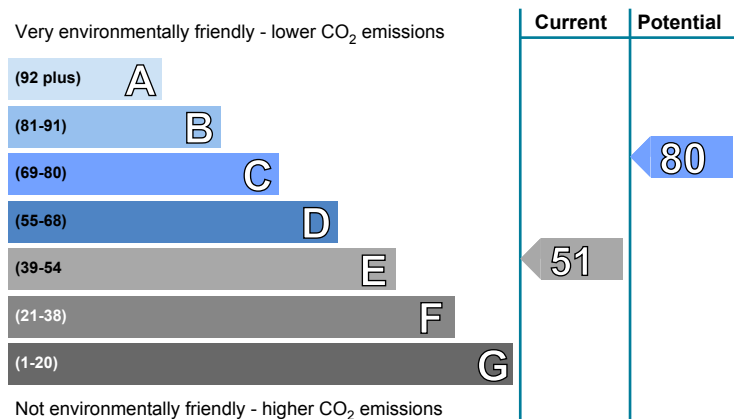
## Environmental Impact (CO<sub>2</sub>) Rating

This graph shows the effect of your home on the environment in terms of carbon dioxide (CO<sub>2</sub>) emissions. The higher the rating, the less impact it has on the environment.

Your current rating is **band E (51)**. The average rating for EPCs in Scotland is **band D (59)**.

The potential rating shows the effect of undertaking all of the improvement measures listed within your recommendations report.
