HOME REPORT

4 WINGATE DRIVE
EAST KILBRIDE
GLASGOW
G74 3HB

4 WINGATE DRIVE, EAST KILBRIDE, GLASGOW, G74 3HB

Dwelling type: Ground-floor flat
Date of assessment: 30 September 2024
Date of certificate: 30 September 2024
Total floor area: 63 m²
Primary Energy Indicator: 234 kWh/m²/year

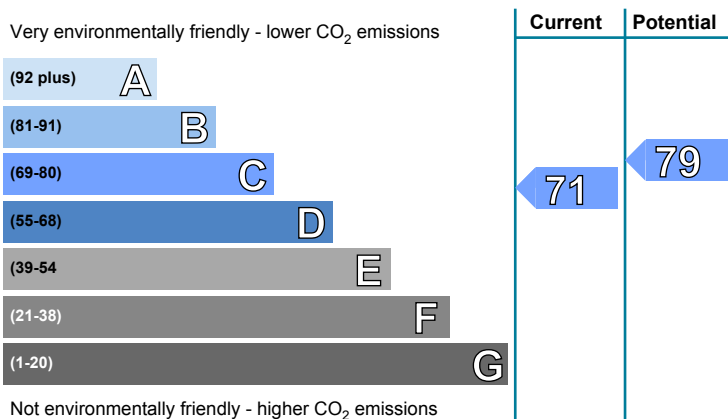
Environmental Impact (CO₂) Rating

This graph shows the effect of your home on the environment in terms of carbon dioxide (CO₂) emissions. The higher the rating, the less impact it has on the environment.

Your current rating is **band C (71)**. The average rating for EPCs in Scotland is **band D (59)**.

The potential rating shows the effect of undertaking all of the improvement measures listed within your recommendations report.
