## HOME REPORT

79 GLEN ESK  
EAST KILBRIDE  
GLASGOW  
G74 3UR

# Energy Performance Certificate (EPC)

79 GLEN ESK, EAST KILBRIDE, GLASGOW, G74 3UR

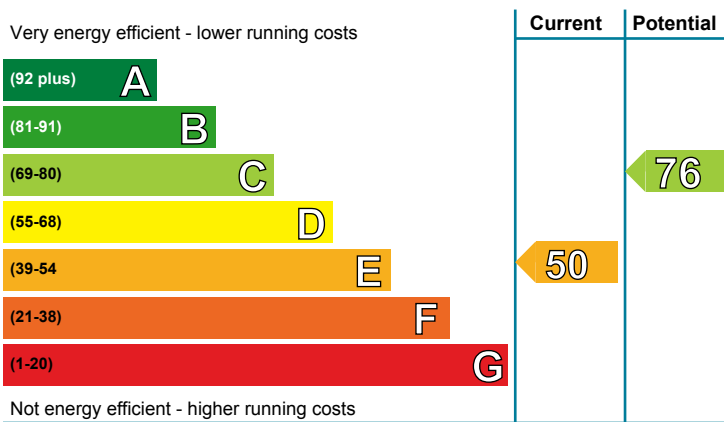
## Energy Efficiency Rating

This graph shows the current efficiency of your home, taking into account both energy efficiency and fuel costs. The higher this rating, the lower your fuel bills are likely to be.

Your current rating is **band E (50)**. The average rating for EPCs in Scotland is **band D (61)**.

The potential rating shows the effect of undertaking all of the improvement measures listed within your recommendations report.

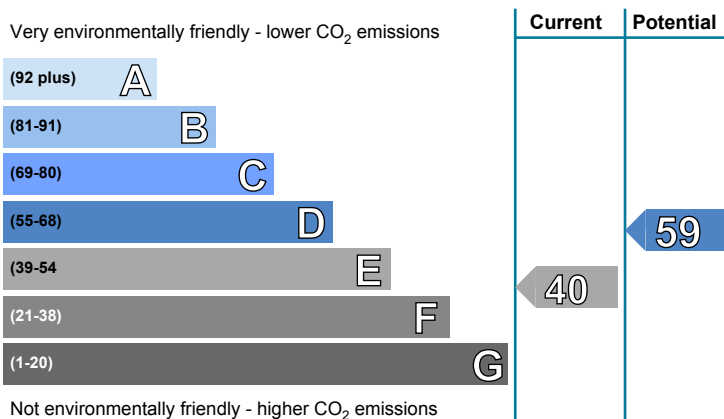
## Environmental Impact (CO<sub>2</sub>) Rating

This graph shows the effect of your home on the environment in terms of carbon dioxide (CO<sub>2</sub>) emissions. The higher the rating, the less impact it has on the environment.

Your current rating is **band E (40)**. The average rating for EPCs in Scotland is **band D (59)**.

The potential rating shows the effect of undertaking all of the improvement measures listed within your recommendations report.
