Home Report

Single Survey

Property address	310 Telford Road East Kilbride Glasgow G75 0DN
Customer	Neil Coleman
Customer address	310 Telford Road East Kilbride Glasgow G75 0DN
Prepared by	Shepherd Chartered Surveyors
Date of inspection	06/01/2026

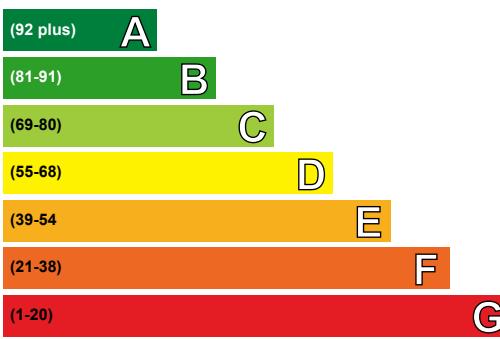
Energy Efficiency Rating

* based upon the cost of energy for heating, hot water, lighting and ventilation, calculated using standard assumptions

Very energy efficient - lower running costs

Not energy efficient - higher running costs

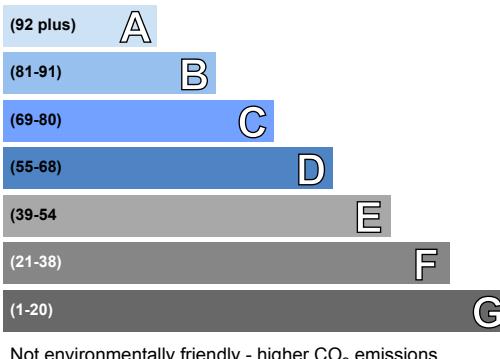
Environmental Impact (CO₂) Rating

Very environmentally friendly - lower CO₂ emissions
