# Home Report

# Single Survey

<b>Property address</b>	140 Waverley East Kilbride Glasgow G74 3PE
<b>Customer</b>	BETH MARSHALL
<b>Customer address</b>	140 Waverley East Kilbride Glasgow G74 3PE
<b>Prepared by</b>	Shepherd Chartered Surveyors
<b>Date of inspection</b>	14/01/2026

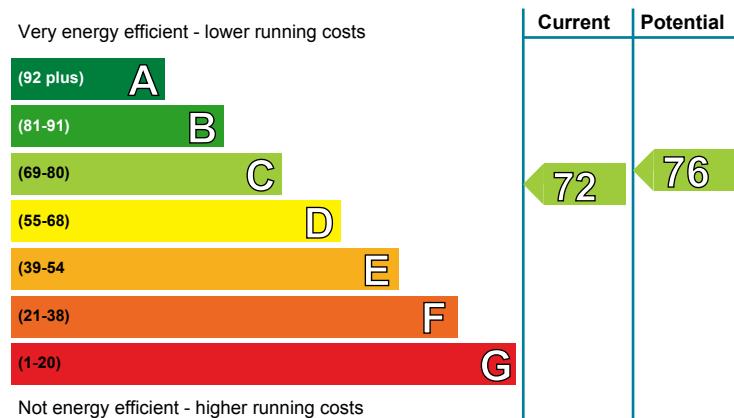
## Energy Efficiency Rating

This graph shows the current efficiency of your home, taking into account both energy efficiency and fuel costs. The higher this rating, the lower your fuel bills are likely to be.

Your current rating is **band C (72)**. The average rating for EPCs in Scotland is **band D (61)**.

The potential rating shows the effect of undertaking all of the improvement measures listed within your recommendations report.

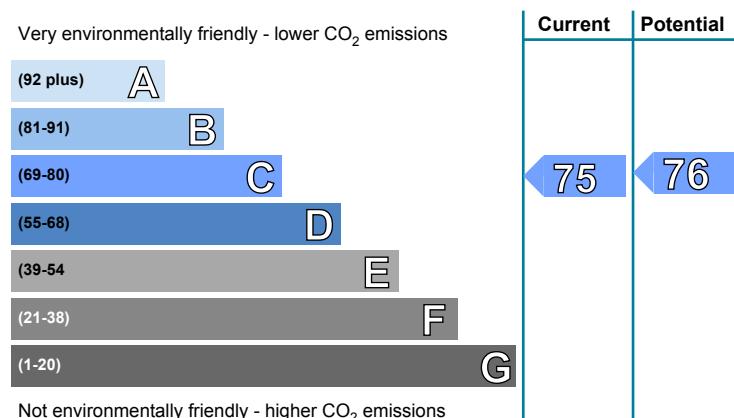
## Environmental Impact (CO<sub>2</sub>) Rating

This graph shows the effect of your home on the environment in terms of carbon dioxide (CO<sub>2</sub>) emissions. The higher the rating, the less impact it has on the environment.
