Home Report

Single Survey

Property address	69 Ness Drive East Kilbride Glasgow G74 2AA
Customer	ANDREW CLAYTON
Customer address	69 Ness Drive East Kilbride Glasgow G74 2AA
Prepared by	Shepherd Chartered Surveyors
Date of inspection	14/01/2026

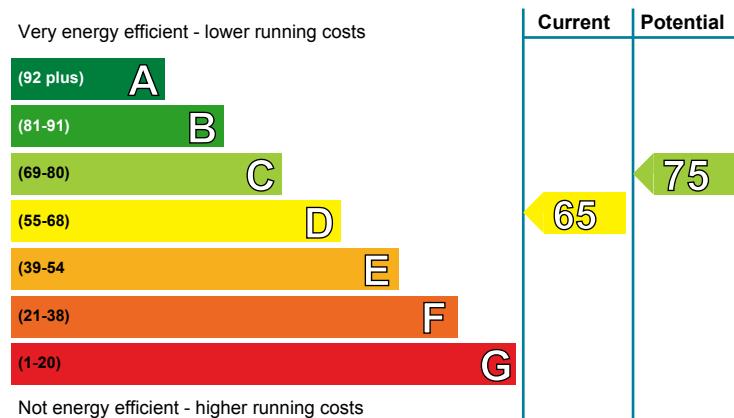
Energy Efficiency Rating

This graph shows the current efficiency of your home, taking into account both energy efficiency and fuel costs. The higher this rating, the lower your fuel bills are likely to be.

Your current rating is **band D (65)**. The average rating for EPCs in Scotland is **band D (61)**.

The potential rating shows the effect of undertaking all of the improvement measures listed within your recommendations report.

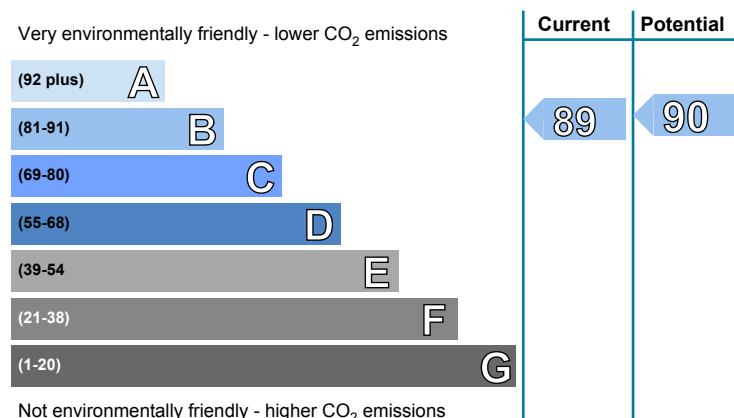
Environmental Impact (CO₂) Rating

This graph shows the effect of your home on the environment in terms of carbon dioxide (CO₂) emissions. The higher the rating, the less impact it has on the environment.
