Home Report

Single Survey

Property address	65 Maxwellton Avenue East Kilbride Glasgow G74 3AF
Customer	Elaine Eunson
Customer address	65 Maxwellton Avenue East Kilbride Glasgow G74 3AF
Prepared by	Shepherd Chartered Surveyors
Date of inspection	02/02/2026

Energy Performance Certificate (EPC)

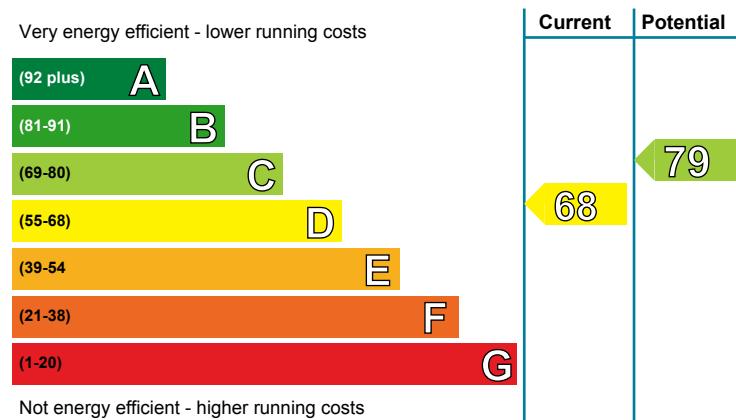
Energy Efficiency Rating

This graph shows the current efficiency of your home, taking into account both energy efficiency and fuel costs. The higher this rating, the lower your fuel bills are likely to be.

Your current rating is **band D (68)**. The average rating for EPCs in Scotland is **band D (61)**.

The potential rating shows the effect of undertaking all of the improvement measures listed within your recommendations report.

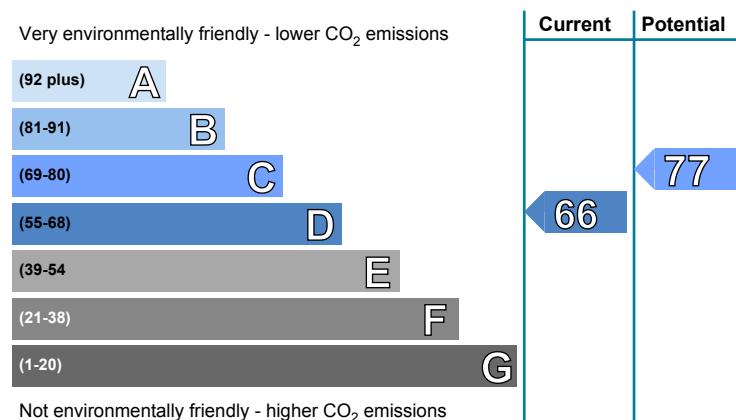
Environmental Impact (CO₂) Rating

This graph shows the effect of your home on the environment in terms of carbon dioxide (CO₂) emissions. The higher the rating, the less impact it has on the environment.
