# Home Report

# Scottish Single Survey

# Single Survey

| Property address | 3 New Plymouth<br>East Kilbride<br>Glasgow<br>G75 8QB |

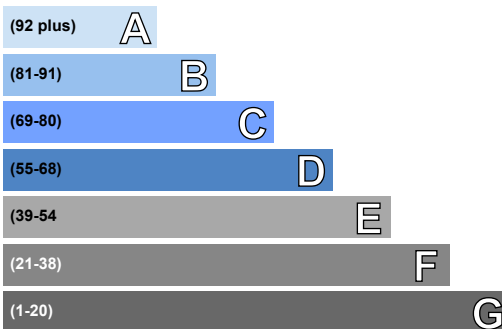
Very environmentally friendly - lower CO<sub>2</sub> emissions

Not environmentally friendly - higher CO<sub>2</sub> emissions
