# Home Report

# Single Survey

<b>Property address</b>	74 Colonsay East Kilbride Glasgow G74 2HF
<b>Customer</b>	Collette Young
<b>Customer address</b>	74 Colonsay East Kilbride Glasgow G74 2HF
<b>Prepared by</b>	Shepherd Chartered Surveyors
<b>Date of inspection</b>	03/03/2026

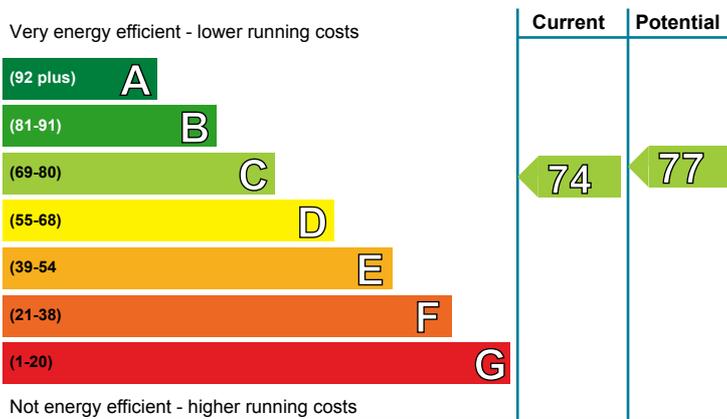
## Energy Efficiency Rating

This graph shows the current efficiency of your home, taking into account both energy efficiency and fuel costs. The higher this rating, the lower your fuel bills are likely to be.

Your current rating is **band C (74)**. The average rating for EPCs in Scotland is **band D (61)**.

The potential rating shows the effect of undertaking all of the improvement measures listed within your recommendations report.

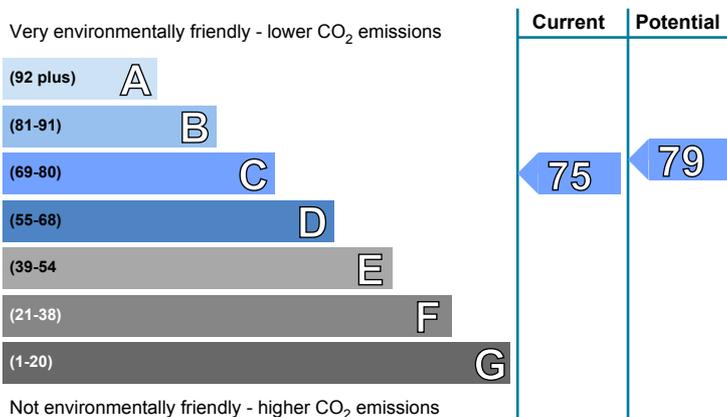
## Environmental Impact (CO<sub>2</sub>) Rating

This graph shows the effect of your home on the environment in terms of carbon dioxide (CO<sub>2</sub>) emissions. The higher the rating, the less impact it has on the environment.
