Home Report

Single Survey

Property address	15 Deveron Road East Kilbride Glasgow G74 2HS
-------------------------	--

Prepared by	Shepherd Chartered Surveyors
--------------------	------------------------------

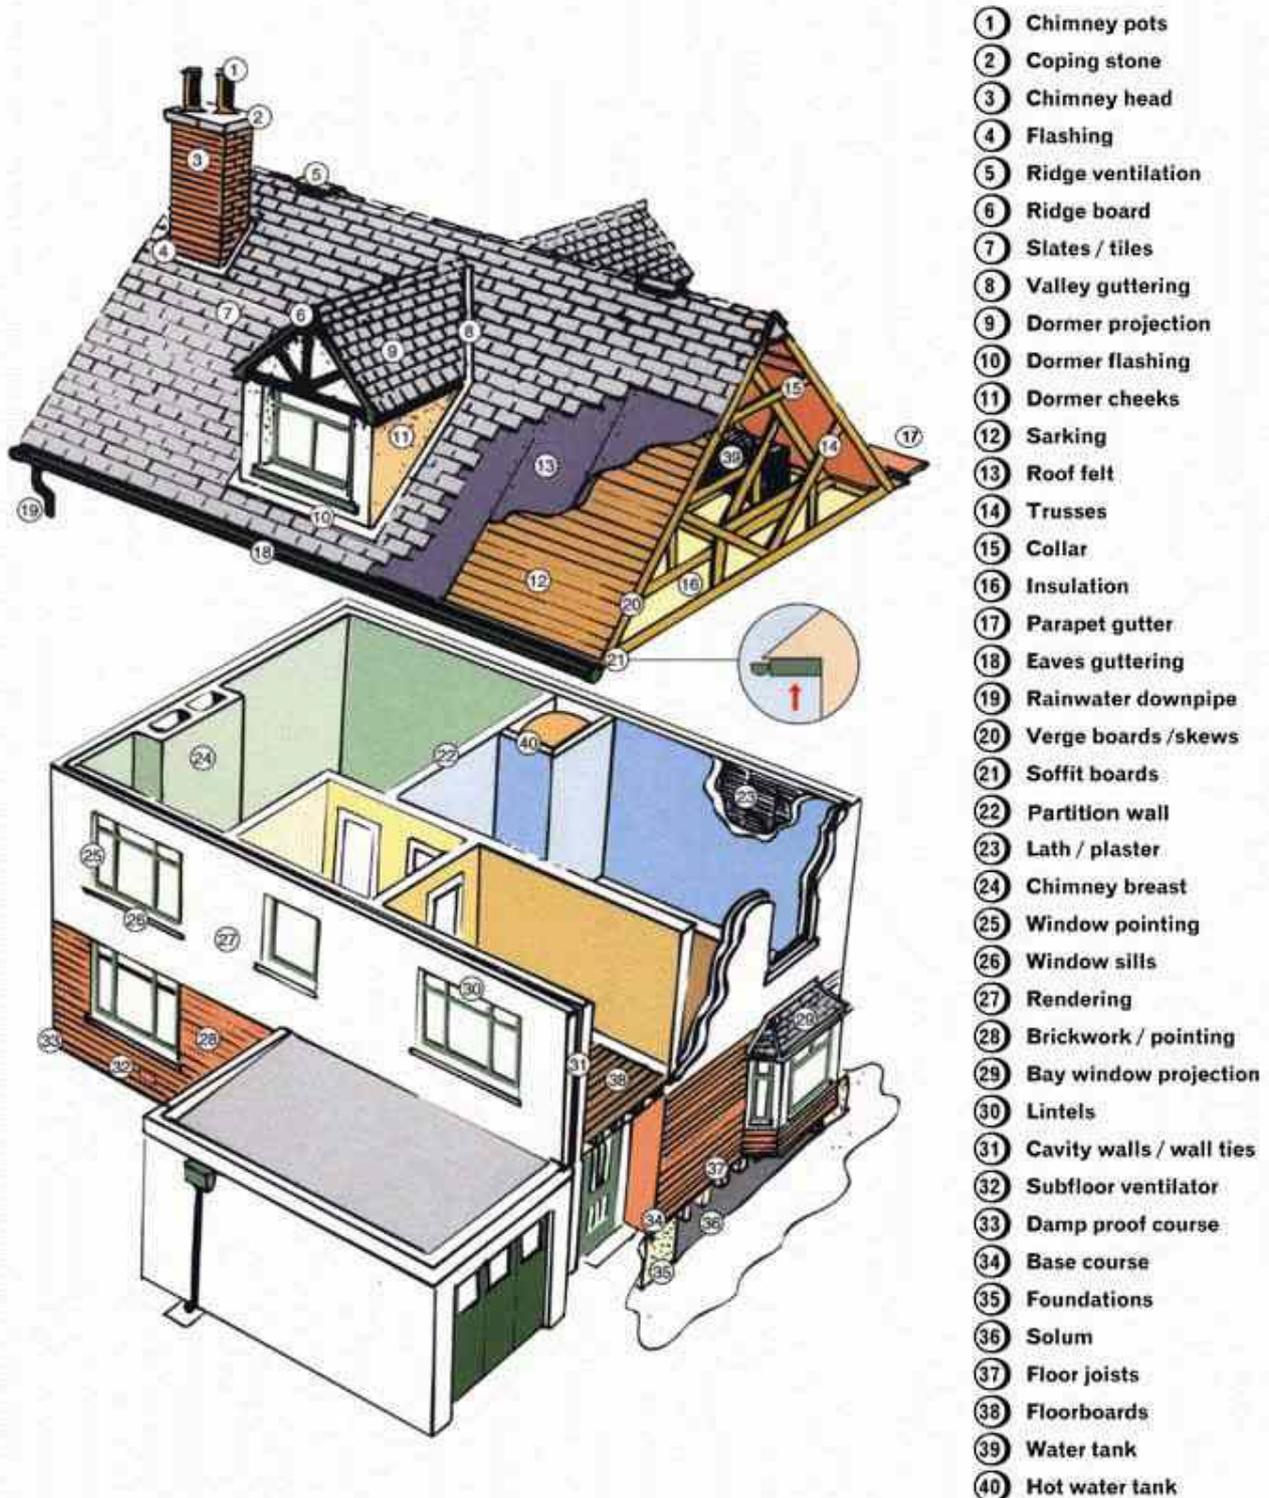
Sectional Diagram showing elements of a typical house

- ① Chimney pots
- ② Coping stone
- ③ Chimney head
- ④ Flashing
- ⑤ Ridge ventilation
- ⑥ Ridge board
- ⑦ Slates / tiles
- ⑧ Valley guttering
- ⑨ Dormer projection
- ⑩ Dormer flashing
- ⑪ Dormer cheeks
- ⑫ Sarking
- ⑬ Roof felt
- ⑭ Trusses
- ⑮ Collar
- ⑯ Insulation
- ⑰ Parapet gutter
- ⑱ Eaves guttering
- ⑲ Rainwater downpipe
- ⑳ Verge boards /skews
- ㉑ Soffit boards
- ㉒ Partition wall
- ㉓ Lath / plaster
- ㉔ Chimney breast
- ㉕ Window pointing
- ㉖ Window sills
- ㉗ Rendering
- ㉘ Brickwork / pointing
- ㉙ Bay window projection
- ㉚ Lintels
- ㉛ Cavity walls / wall ties
- ㉜ Subfloor ventilator
- ㉝ Damp proof course
- ㉞ Base course
- ㉟ Foundations
- ㊱ Solum
- ㊲ Floor joists
- ㊳ Floorboards
- ㊴ Water tank
- ㊵ Hot water tank

Reference may be made in this report to some or all of the above component parts of the property. This diagram may assist you in locating and understanding these items.
