# Home Report

# Scottish Single Survey

# Single Survey

<b>Property address</b>	15 Westoe Path East Kilbride Glasgow G75 9PS
-------------------------	---

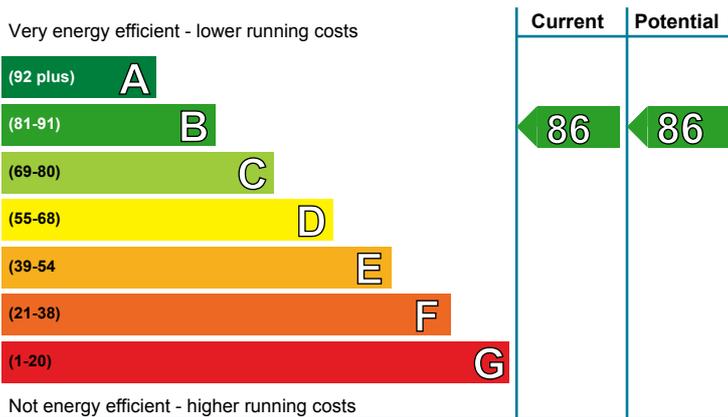
## Energy Efficiency Rating

This graph shows the current efficiency of your home, taking into account both energy efficiency and fuel costs. The higher this rating, the lower your fuel bills are likely to be.

Your current rating is **band B (86)**. The average rating for EPCs in Scotland is **band D (61)**.

The potential rating shows the effect of undertaking all of the improvement measures listed within your recommendations report.
