Meadowview Manor,  
Halket Road,  
Lugton,  
Kilmarnock,  
KA3 4EE

# Home Report

# Single Survey

## Survey Report on:

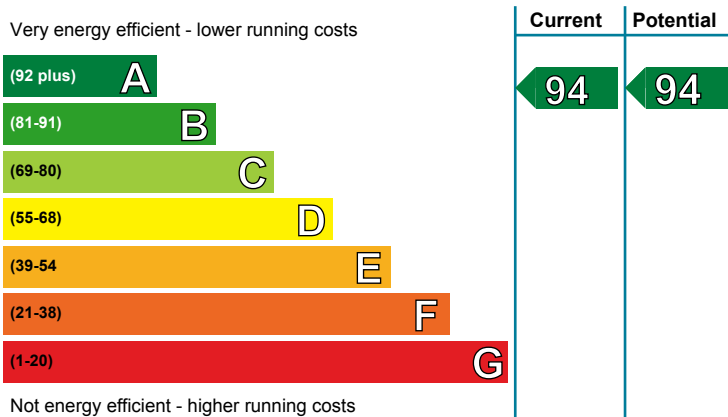
## Energy Efficiency Rating

This graph shows the current efficiency of your home, taking into account both energy efficiency and fuel costs. The higher this rating, the lower your fuel bills are likely to be.

Your current rating is **band A (94)**. The average rating for EPCs in Scotland is **band D (61)**.

The potential rating shows the effect of undertaking all of the improvement measures listed within your recommendations report.

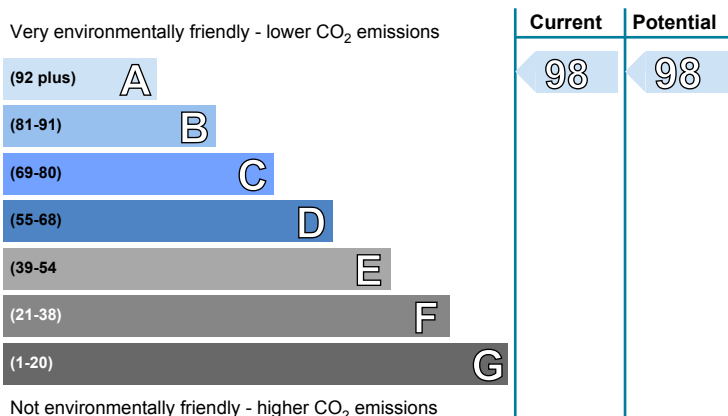
## Environmental Impact (CO<sub>2</sub>) Rating

This graph shows the effect of your home on the environment in terms of carbon dioxide (CO<sub>2</sub>) emissions. The higher the rating, the less impact it has on the environment.
