YOUR ONESURVEY
HOME REPORT

Flat 2/6 - Flat (25)
112 Cowcaddens Road
Cowcaddens
Glasgow, G4 0HL

SINGLE SURVEY

Single Survey

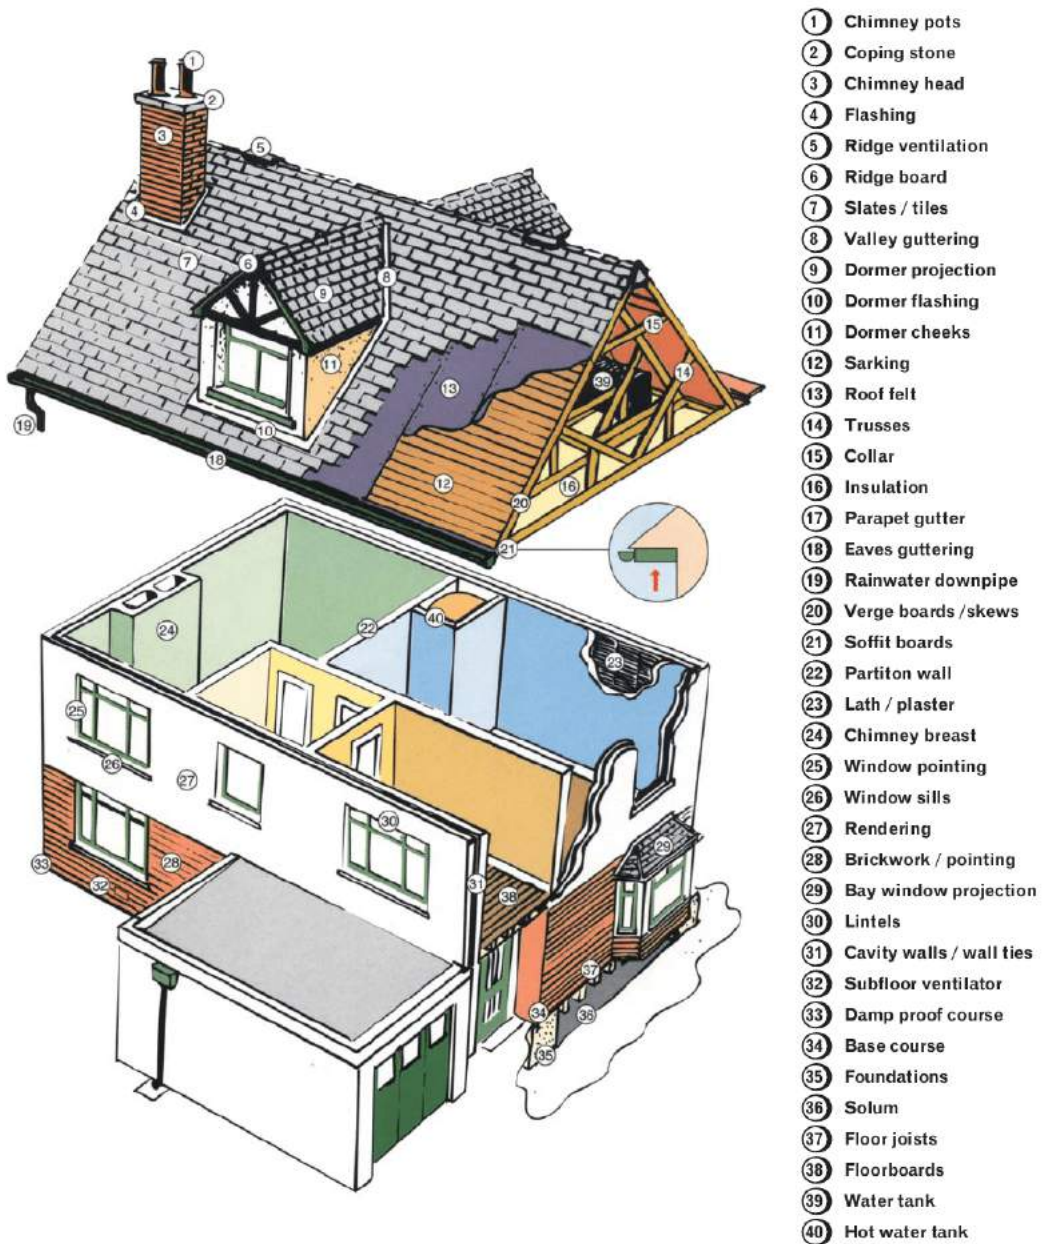
Sectional Diagram showing elements of a typical house

Reference may be made in this report to some or all of the above component parts of the property. This diagram may assist you in locating and understanding these items.
